SPOONWOOD POND DAM

NH 00338

PHASE I INSPECTION REPORT  
NATIONAL DAM INSPECTION PROGRAM

AUGUST 1978

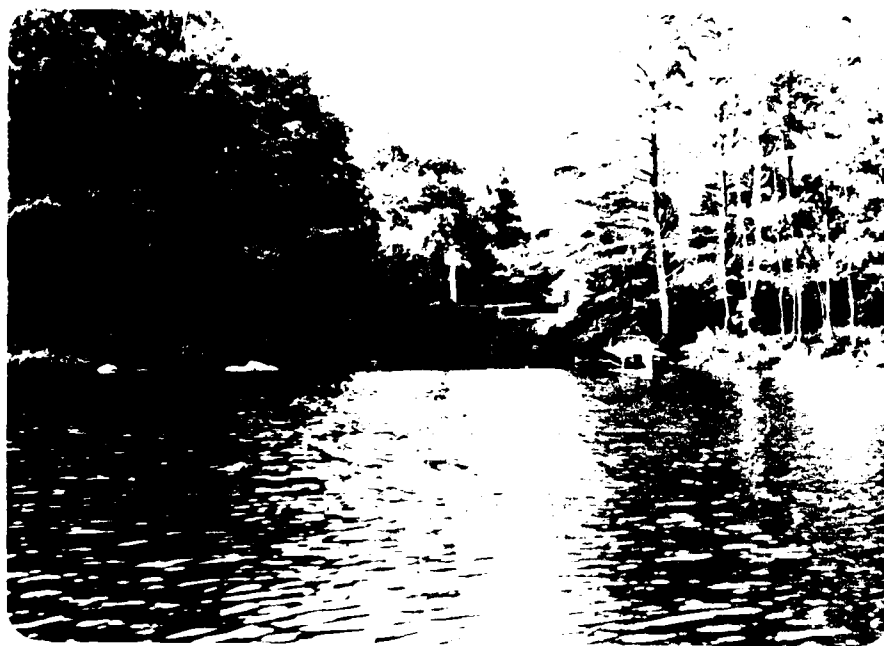
Overview of dam from downstream

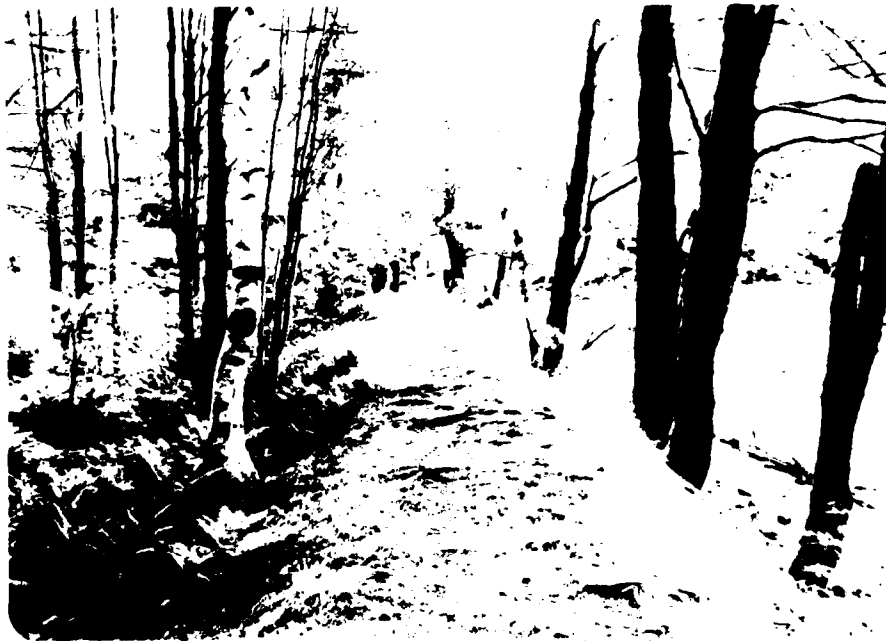
Overview from left abutment

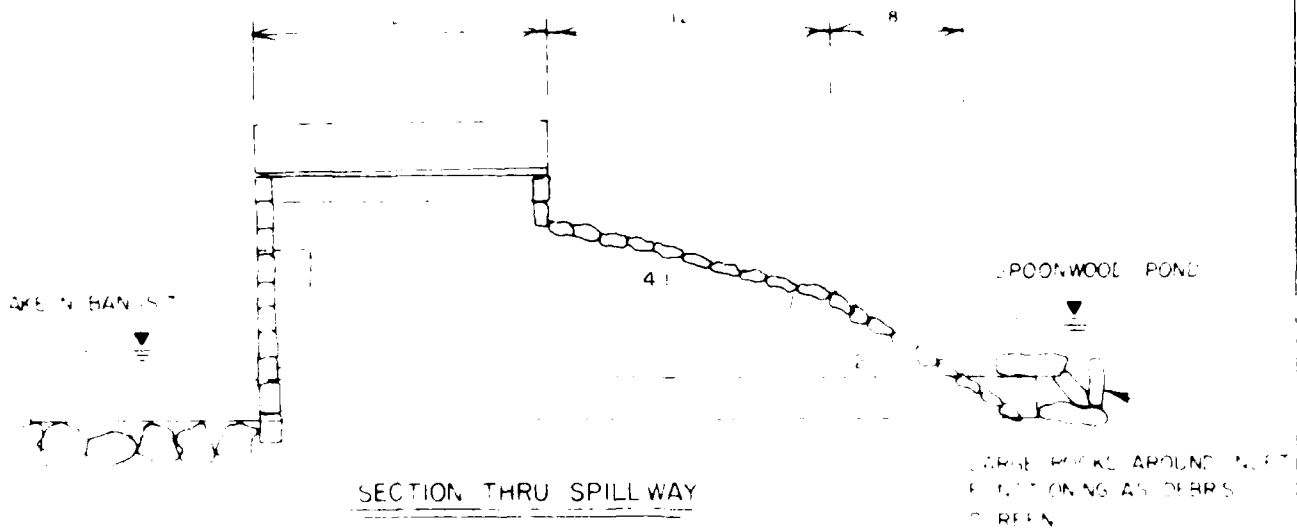
NOTE: SPOONWOOD POND DRAWDOWN DURING TIME OF INSPECTION
